## Pietermaritzburg Integrated Rapid Transport Network Itemised assessment of the Church Street section

**For direct submission to *Amafa aKwaZulu-Natali***

**Phase IV submission:  
Timber Street to Boschhoff Street  
June 2016**

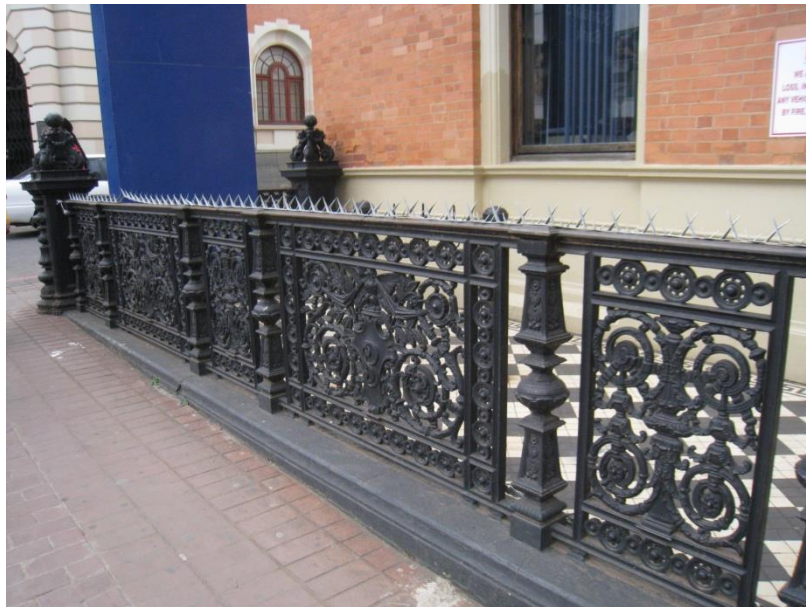
Currently this building has undergone a number of other layers of renovation in recent times. Its exterior is in reasonably good condition. However, it must be noted that the edge of the paving / slab of the external apron of the building is damaged to the right of the central entrance area. There is also significant staining of the encaustic tiles. **PLEASE NOTE THAT ANY WORK CARRIED OUT IN THE PROXIMITY OF THIS BUILDING HAS TO BE DONE WITH EXTREME CARE.**

**Fig 2: Detail of the railed enclosure onto Church Street. This is the most significantly affected area**

- The work on site must be supervised at all times.
- Given that the time between the documentation exercise in this report and the commencement of work on site can result in further damage to the structure, prior to carrying out work, the contractor must take a thorough, detailed set of dated photographs in order to be able to monitor the works in the event of damage. Particularly, the damaged apron and the staining on the encaustic tiles must be documented.

- It must not be located against the walls of the building or the precinct of the cast iron enclosure in any manner.
- When excavation is being carried out, the base of the building and the foundations must be protected from impact

- No pneumatic machinery is to be used in close proximity to the walls of the building.
- At the slightest sight of cracks to the walls that were not in existence prior to work being carried out, all work in proximity to the building and its cracks must cease.

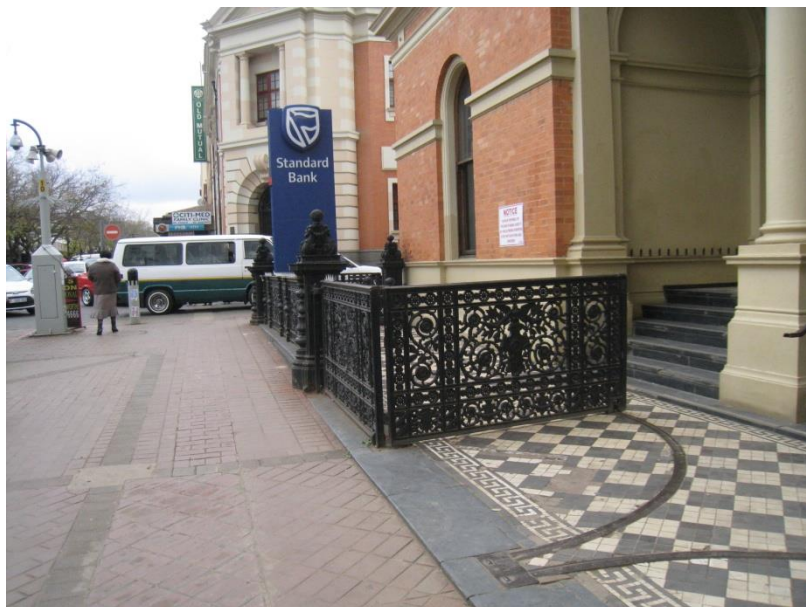
**Fig 3: Showing interface between street paving and building paving edge**

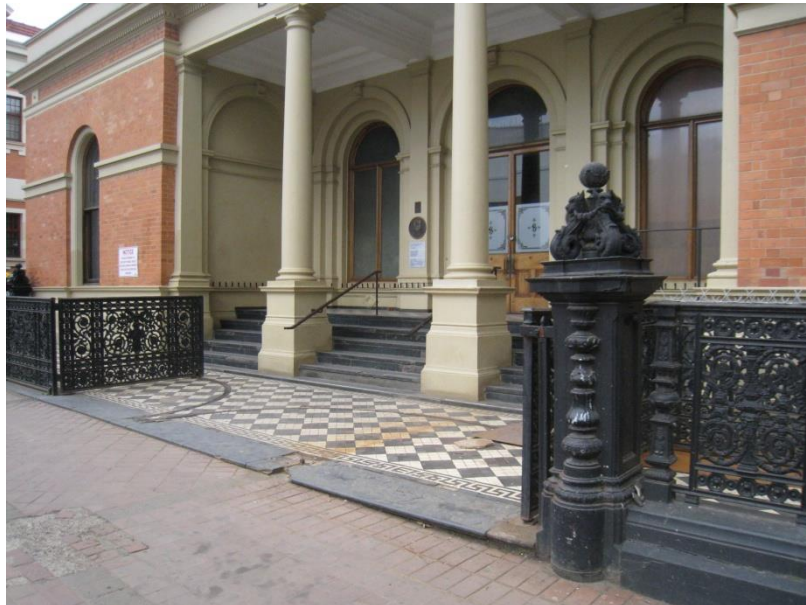
**Fig 5: Showing the extent of the paving interface**

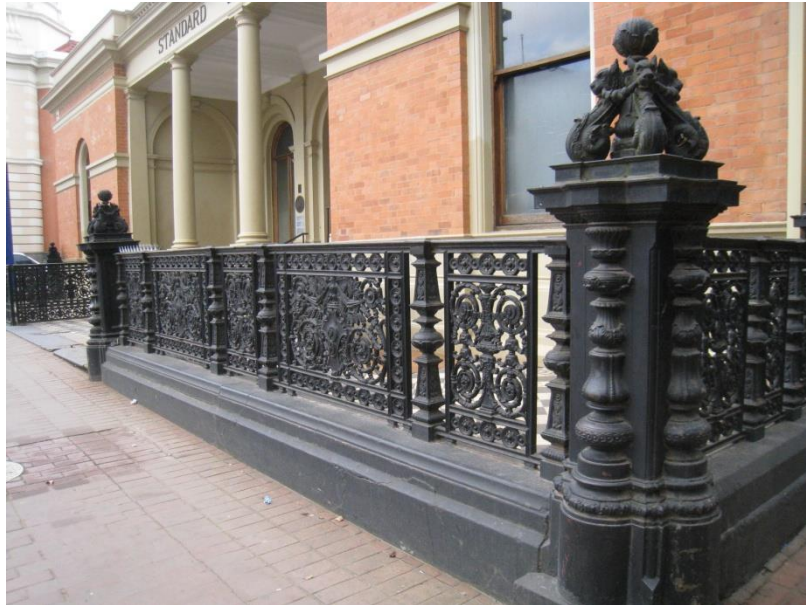
**Fig 6: Reasonable condition to the northern corner of the street face**

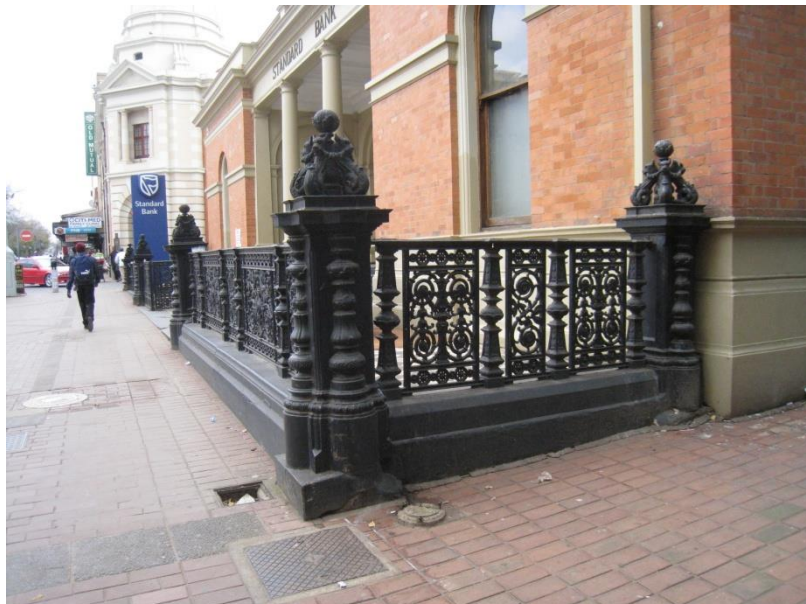
**Fig 7: Note drains and municipal service areas in proximity of the railings**

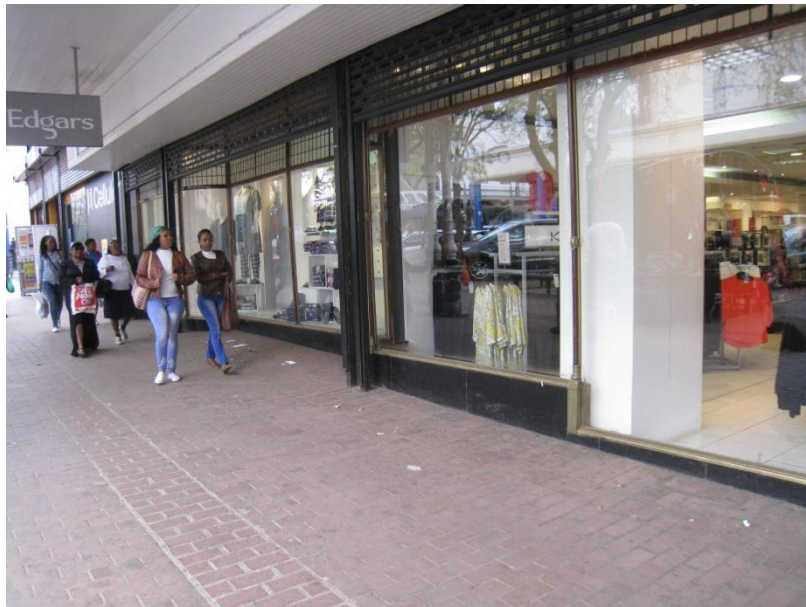
**Fig 17: Showing intact shopfront and pavement – shopfront interface**

- Work carried out against the historic shop front must be approached with due care and materials must not be laid against it.
- When excavation is being carried out, the base of the building and the foundations must be protected from impact.

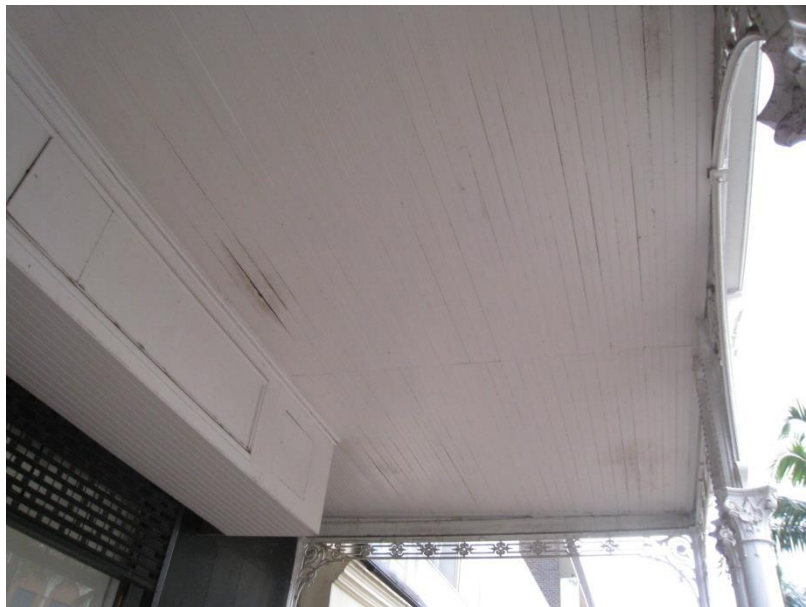
Furthermore, whilst this building is not in ideal condition (work on the canopy ceiling and some general cosmetic maintenance required), apart from the work carried out in order to secure the shopfront some years ago, it is , it is reasonably intact. Note that it is an important building in this section of Church Street. Note also that the base of the building has been previously impacted upon with the paving of Church Street during the pedestrianisation process, and that this should be taken cognizance of. Of great concern, however, is the proliferation of pasted posters on the column bases. These should be removed upon completion of the works.

**Fig 18: Maintenance required in ceiling to canopy**

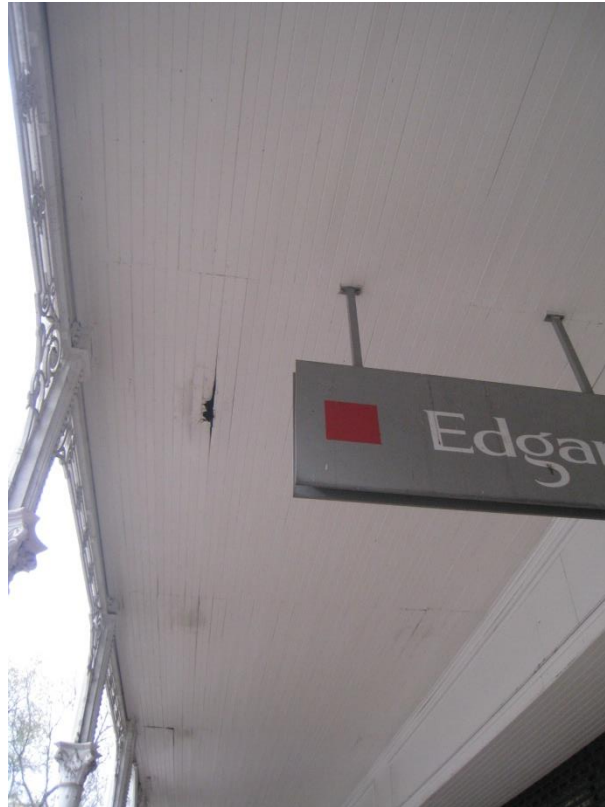
**Fig 19: Further maintenance required in ceiling to canopy**

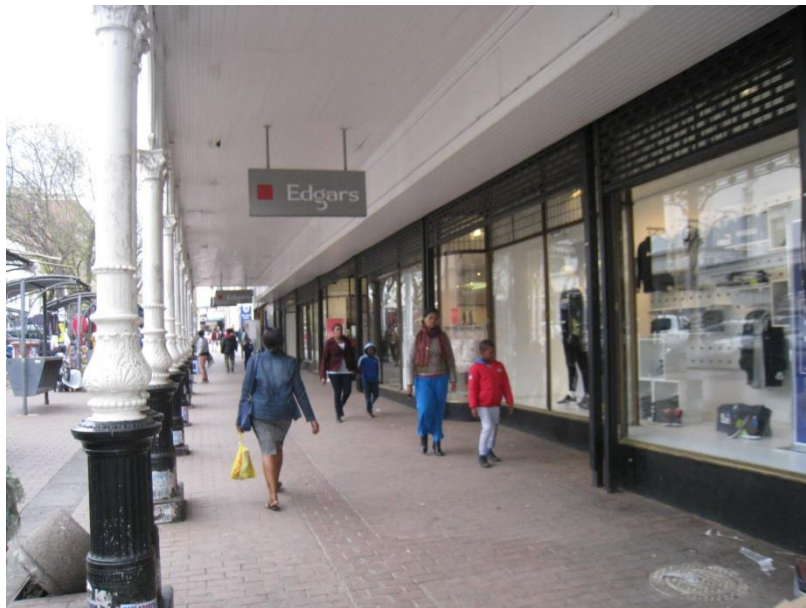
**Fig 20: Note disrupted street furniture to the left and municipal services to the right in the covered pavement**

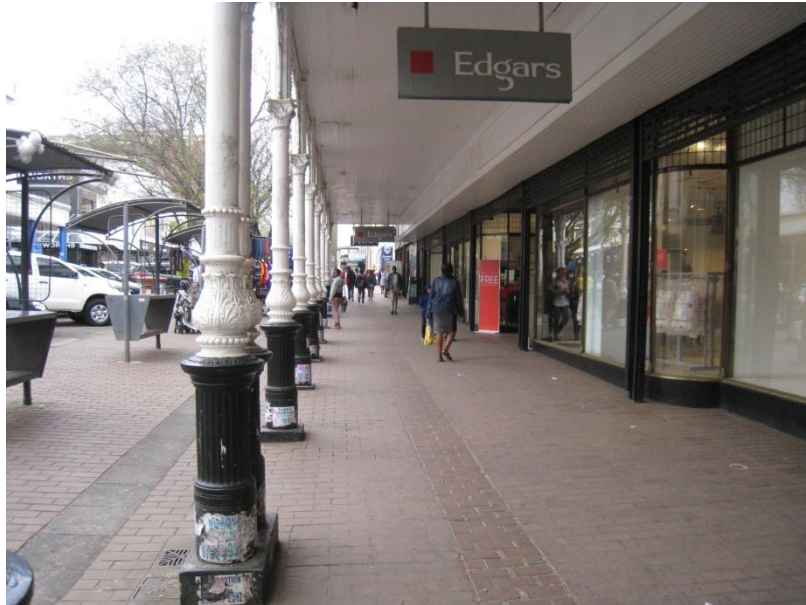
**Fig 21: Showing the illegal placards placed on the column bases**

- The work on site must be supervised at all times.
- Given that the time between the documentation exercise in this report and the commencement of work on site can result in further damage to the pavement, prior to carrying out work, the contractor must take a thorough, detailed set of dated photographs in order to be able to monitor the works in the event of damage.

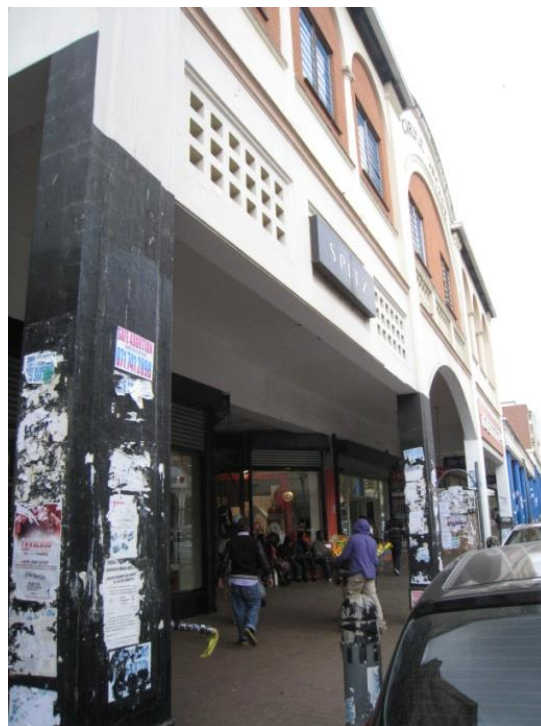
**Fig 28: Showing soffit and second floor, and the bills stuck on the columns**

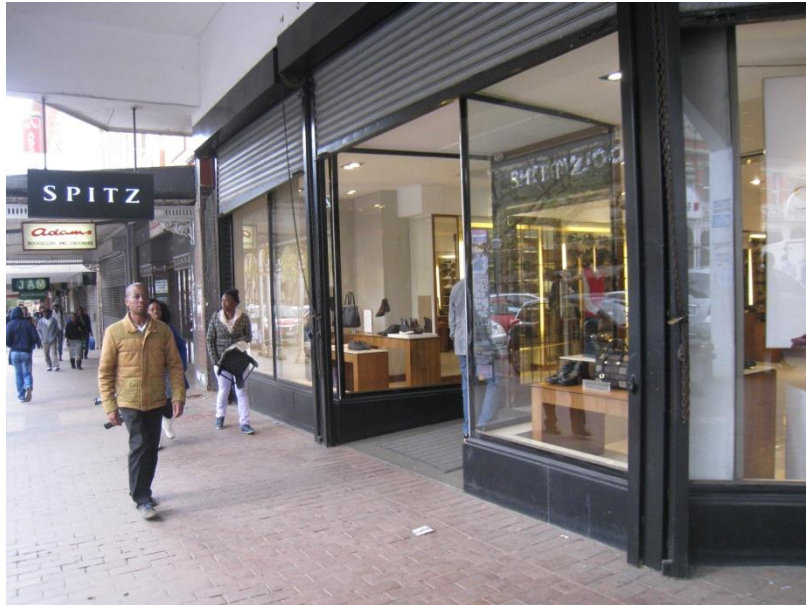
**Fig 31: The interface between shopfront and pavement. Threshold has been reworked to brand the shop in question**

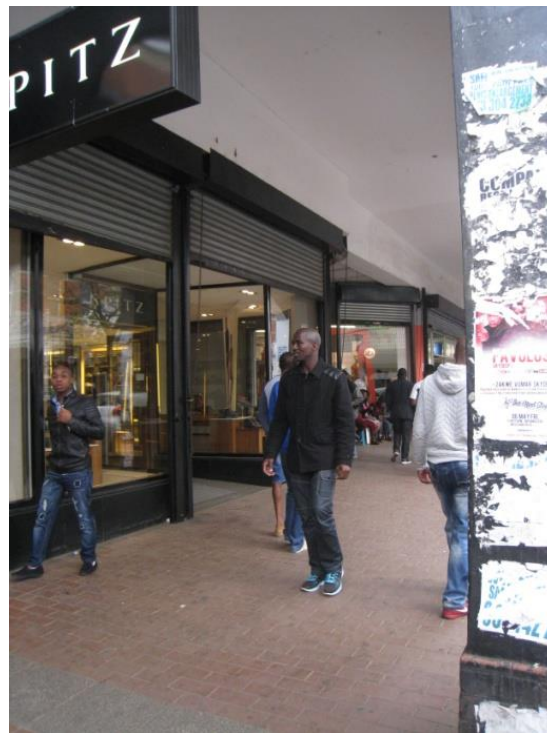
**Fig 32: Note posters applied to columns**

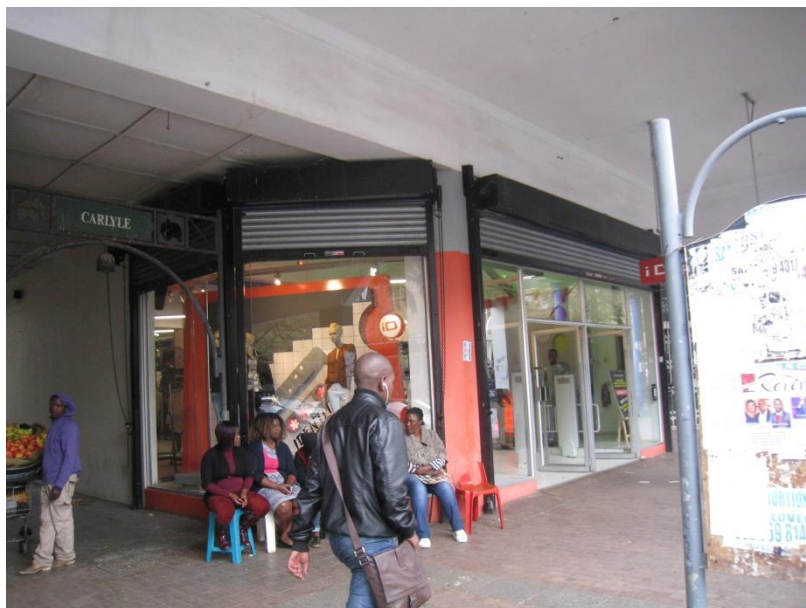
**Fig 35: Showing threshold alterations and interface with paving**

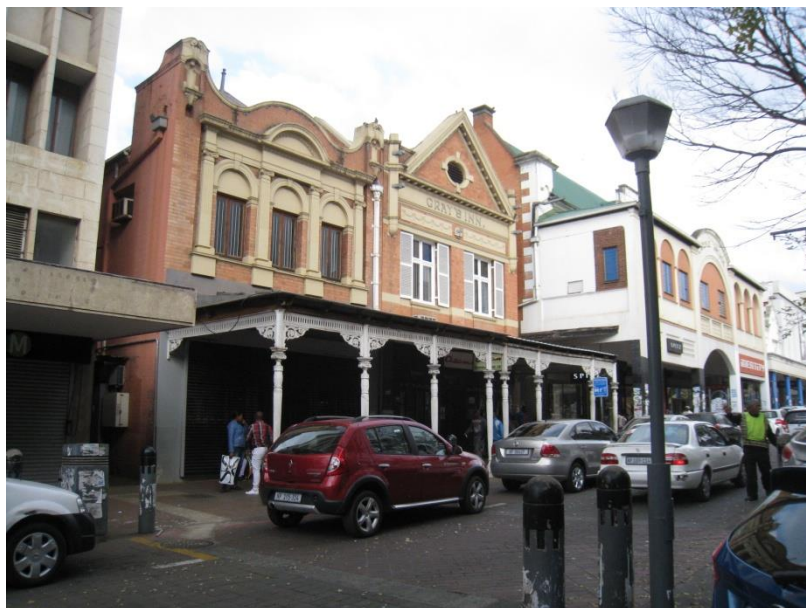
**Fig 41: Showing the two buildings together against 228 Church Street with the projecting veranda**

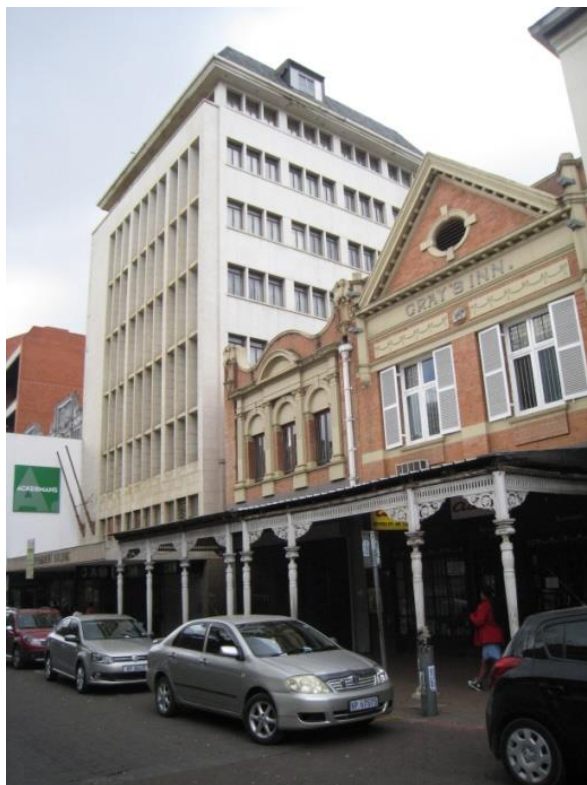
**Fig 43: Two buildings against 234 Church Street**

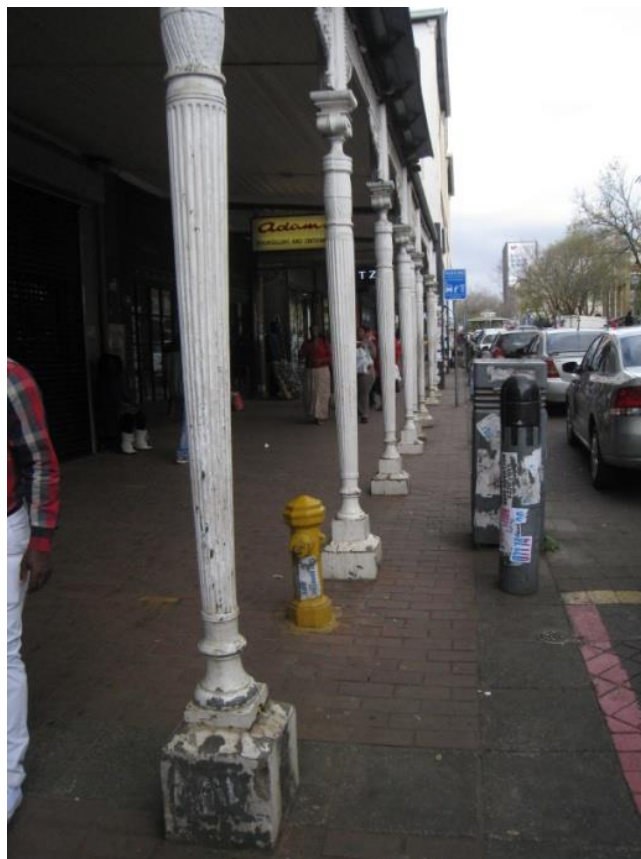
**Fig 45: Showing line of column bases – note fire hydrant in line with collonade**

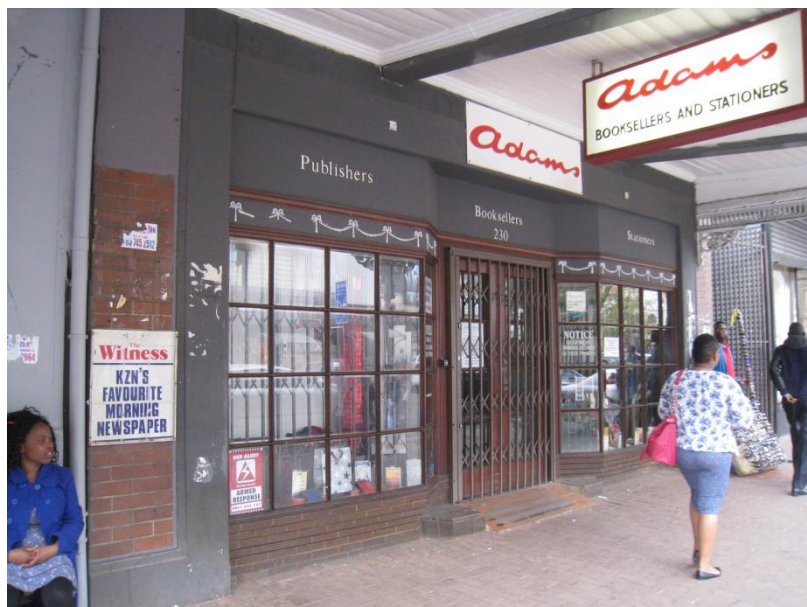
**Fig 48: Showing shopfront – pavement interface**

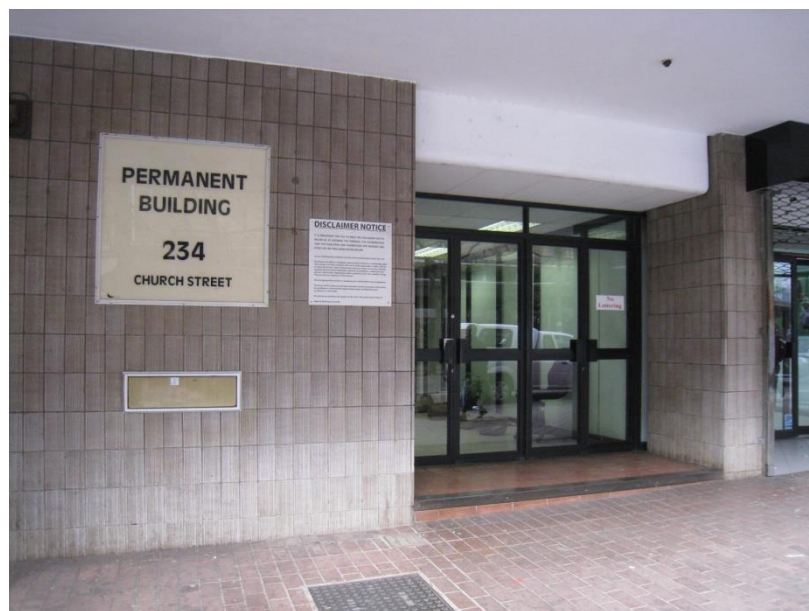
**Fig 50: Front entrance of Permanent Building showing detailing at threshold and building – pavement interface**

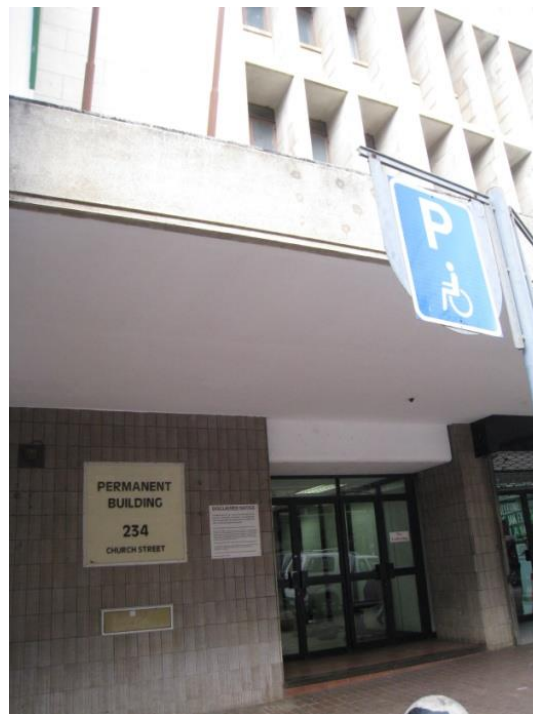
*Fig 51: Front of building showing soffit of cantilevered slab across pavement*

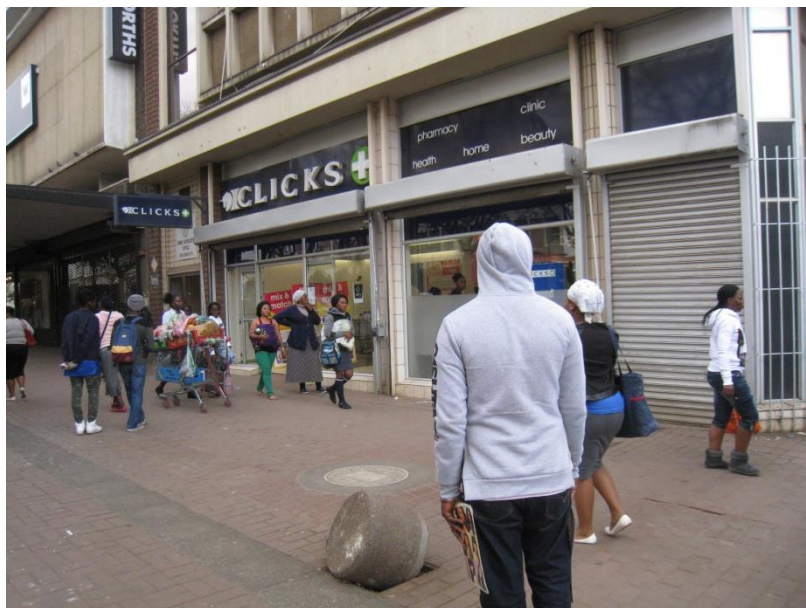
**Fig 54: Showing shopfront – pavement – pedestrianized street interface**

- The work on site must be supervised at all times.
- Given that the time between the documentation exercise in this report and the commencement of work on site can result in further damage to the structure, prior to carrying out work, the contractor must take a thorough, detailed set of dated photographs in order to be able to monitor the works in the event of damage.

- When excavation is being carried out, the base of the building and the foundations must be protected from impact
- No pneumatic machinery is to be used in close proximity to the walls of the building.

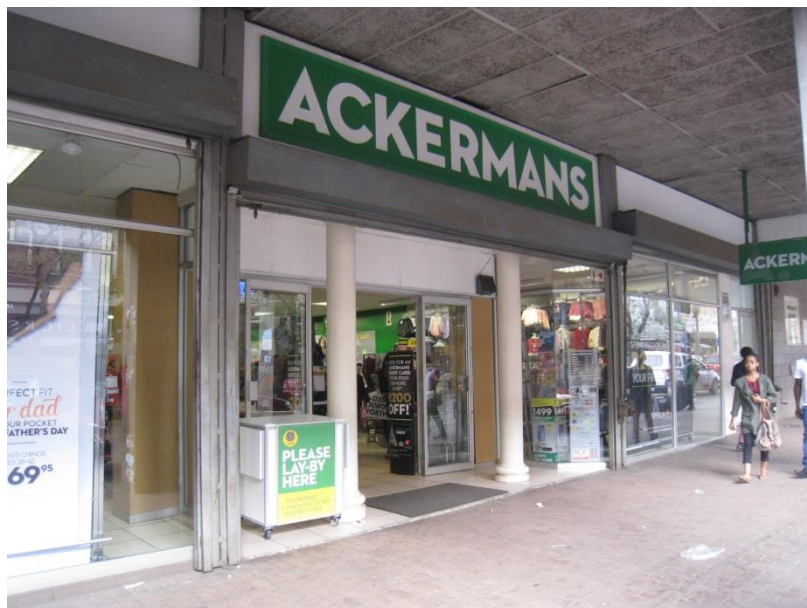
**Fig 56: Showing shopfront – pavement interface, paired simple Roman Doric columns and Heraklith or similar ceiling to the underside of the canopy**

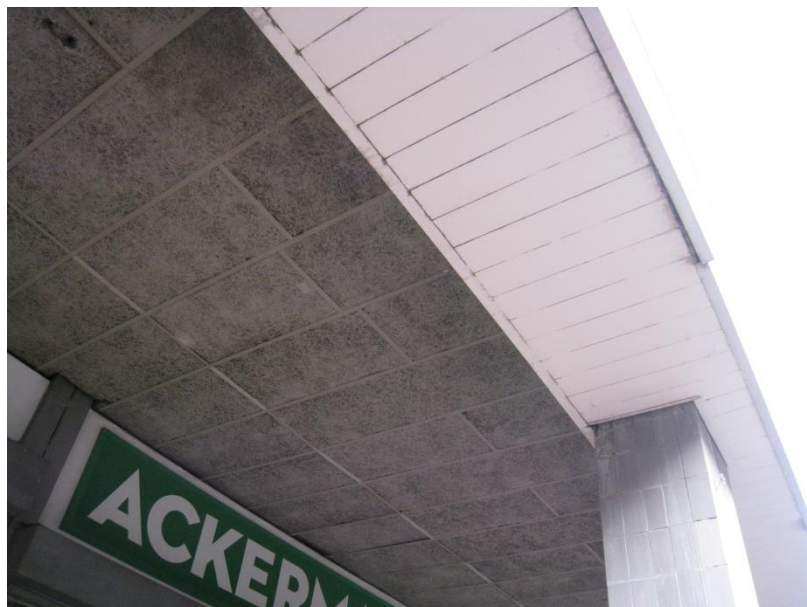
**Fig 57: Close up of ceiling and edge of canopy. Note column encased in tiles**

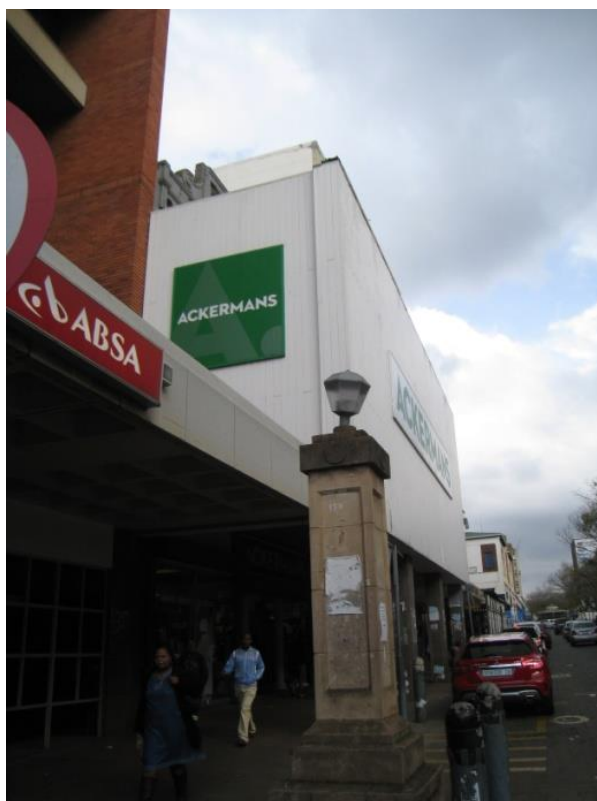
**Fig 58: Streetscape showing obscurity of the Nathan's Chambers double gable**

- The work on site must be supervised at all times.
- Given that the time between the documentation exercise in this report and the commencement of work on site can result in further damage to the structure, prior to carrying out work, the contractor must take a thorough, detailed set of dated photographs in order to be able to monitor the works in the event of damage.

- When excavation is being carried out, the base of the building and the foundations must be protected from impact
- No pneumatic machinery is to be used in close proximity to the walls of the building.

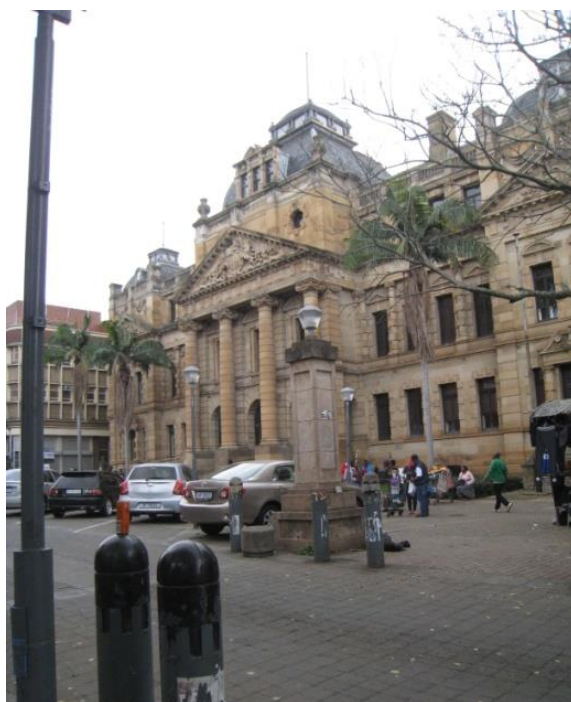
**Fig 29: General view of Colonial Building from across the street. Note all the paraphernalia in the street**

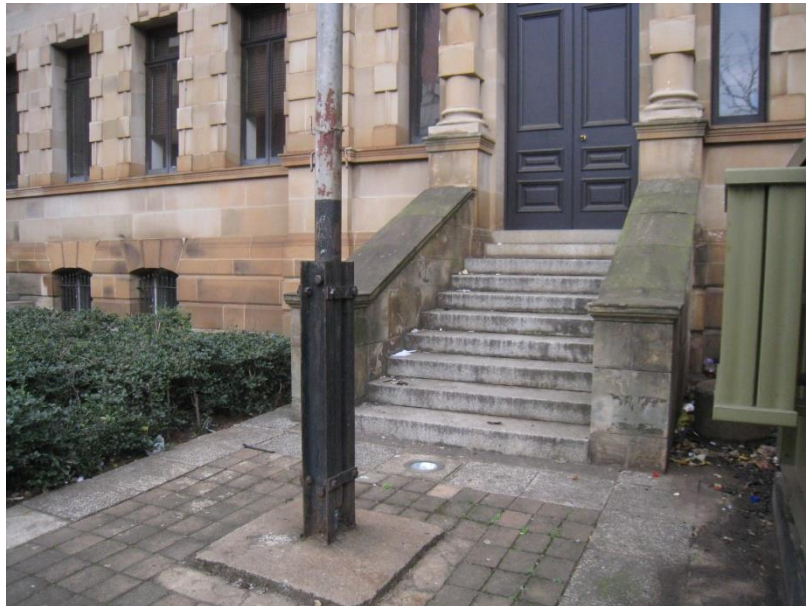
**Fig 60: Showing flagpole to secondary entrance to Colonial Building. Note interface between paving, planter, stairs, flagpole and substation to the right**

The Colonial Building has been extensively renovated in recent years, yet this work has had no impact on the surrounds. Whilst the building is in generally good condition, the design decisions in the precinct, which extend to the placing of a substation in the corner, have not done the area, or the building, any favours.

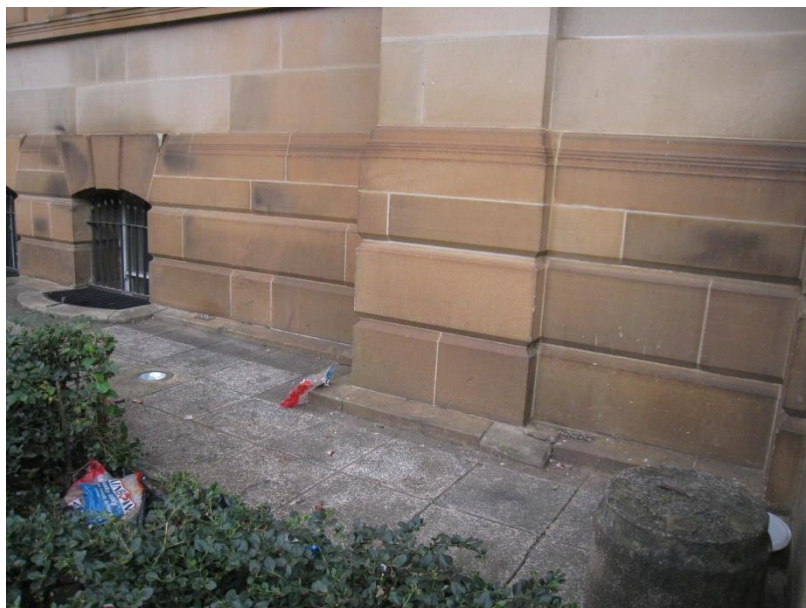
***Fig 62: Interface between rusticated base and paving***

- It is recommended that the extant paving adjacent to the footprint of the building be retained, and that a course of this paving act as the guideline for the laying of the new sections. This will not only act as a buffer in protecting the building, but also indicate quite clearly the line of the old and the new.

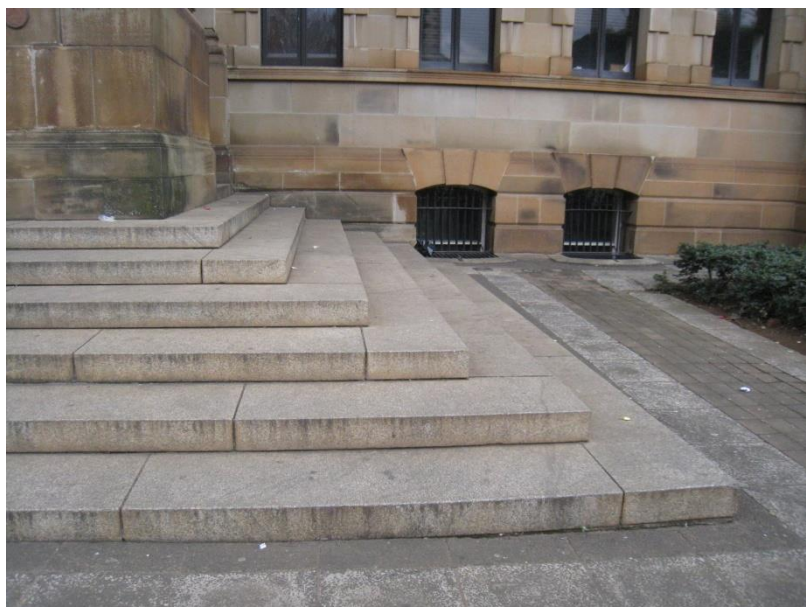
***Fig 63: Showing interface between stairs and paving to the plaza***

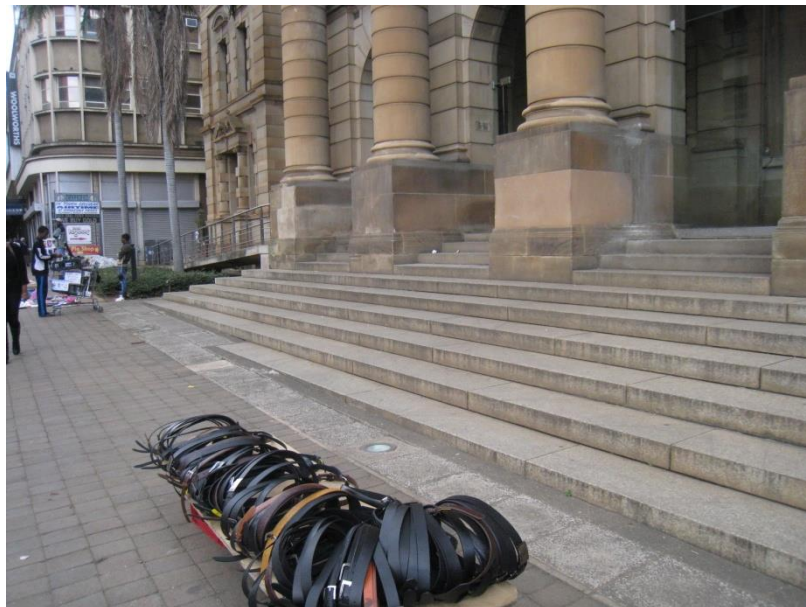
**Fig 65: Front steps of the Colonial Building. Note interface between stairs and paving**

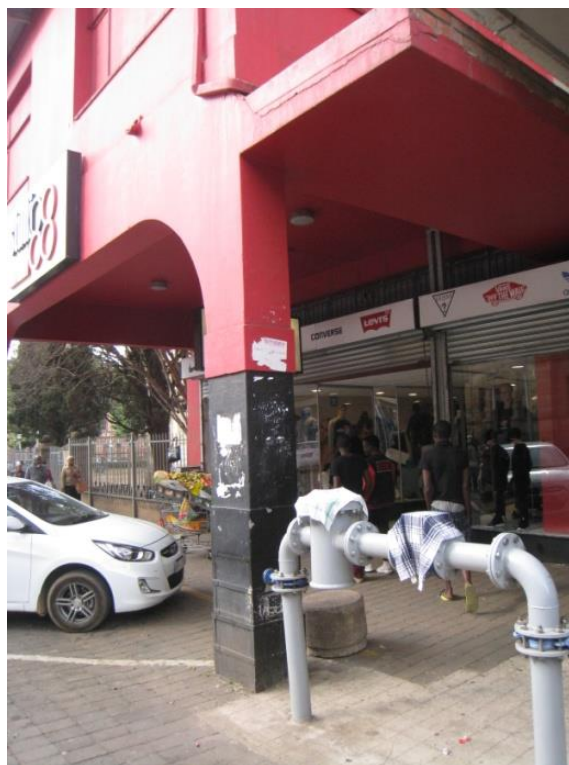
This building has been extensively altered and is not in a particularly good condition, evidenced by the damp on the ceiling of the canopy, and the capricious choice of paint and paint quality. However, it must be treated in accordance with the guidelines for any other building of its standing in the street.

**Fig 67: View towards building showing interface of street and building**

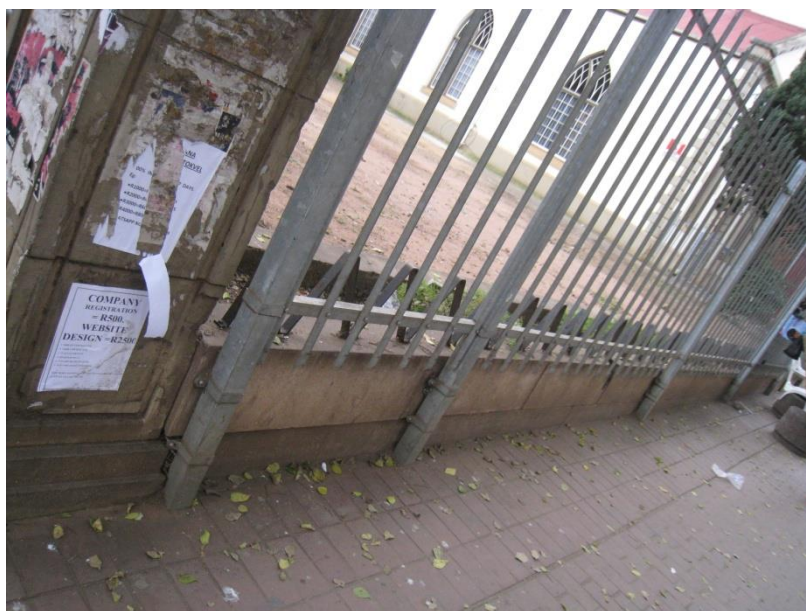
Generally, the walling suffers from extreme lack of maintenance, the effects of continual and unpoliced bill sticking as well as material damage from damp.

**Fig 71: Junction between wall, fixings of the palisade onto the wall, and the wall pavement interface**

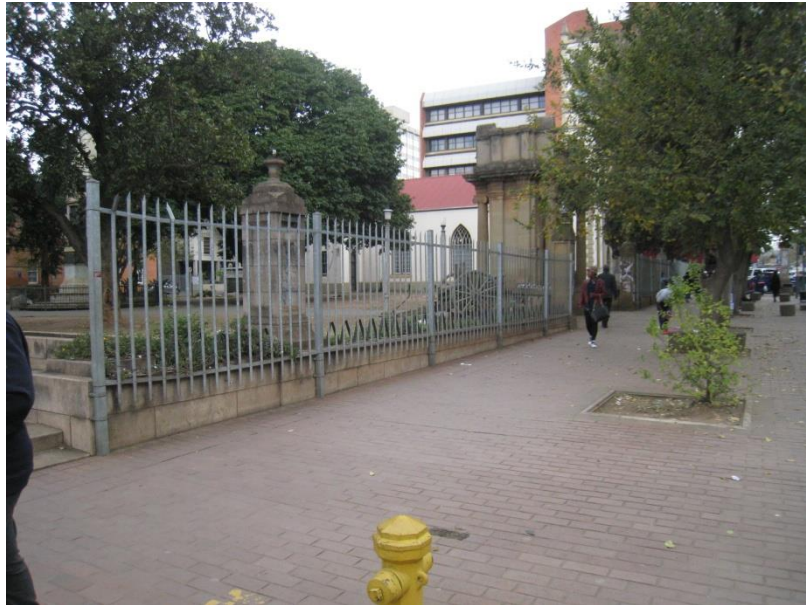
**Fig 79: View up Church Street showing the wall – pavement interface.**

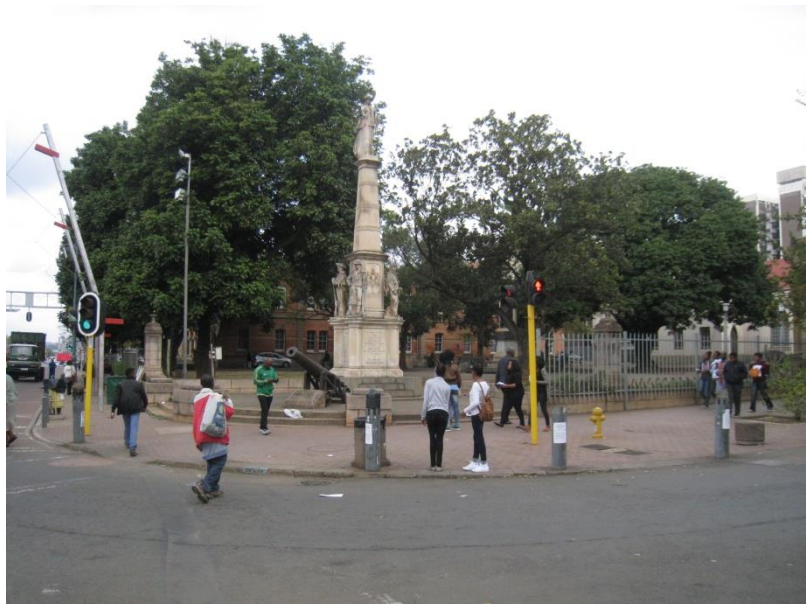
**Fig 80: View from corner of Albert Luthuli Street and Church Street. Note lack of planning and coherence in the placing of lighting, street furniture, etc.**

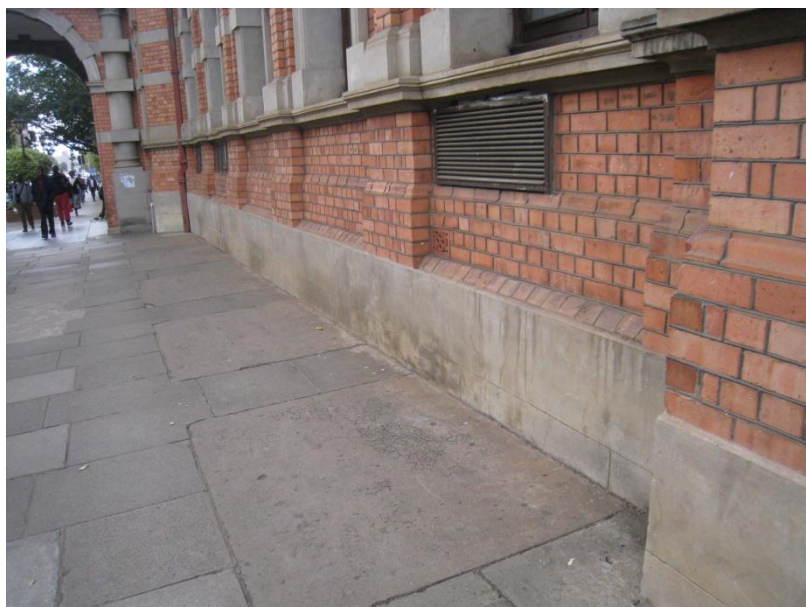
**Fig 84: General view of the plastered plinth – pavement interface**

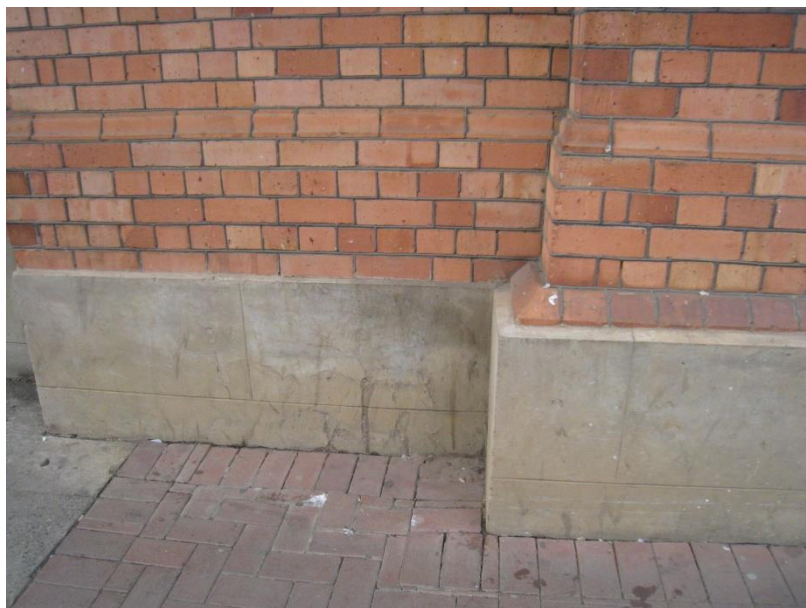
**Fig 89: New brick paving stops**

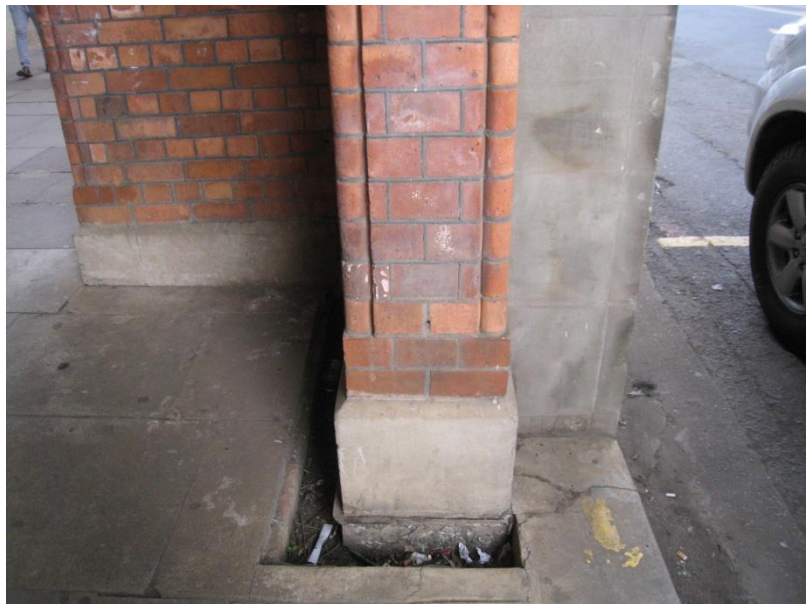
**Fig 94: Showing base to Church Street Entrance to City Hall**

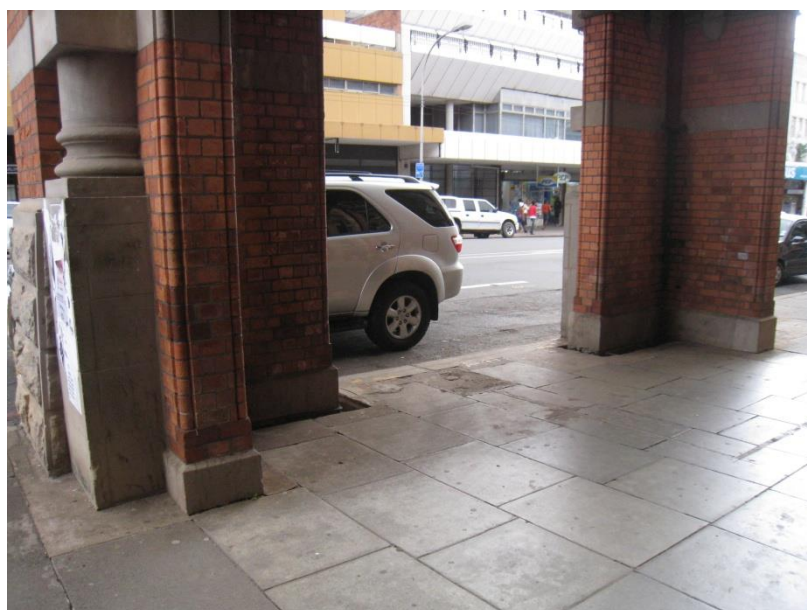
***Fig 101: Showing the general condition of the Church Street Entrance to the City Hall***

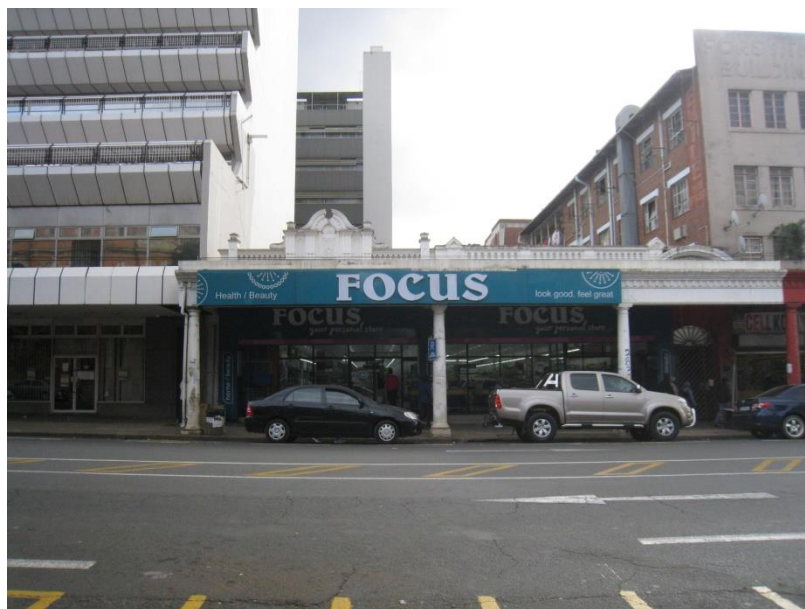
This structure has been extensively altered and has suffered from much abuse in recent years. There is little left by way of a shopfront, nor is there any evidence at street level as to what the original elevation offered. Further, the building may have been renovated in recent years, but it has not been maintained. These observations inform the recommendations.

**Fig 102: 279 Church Street from across the street**

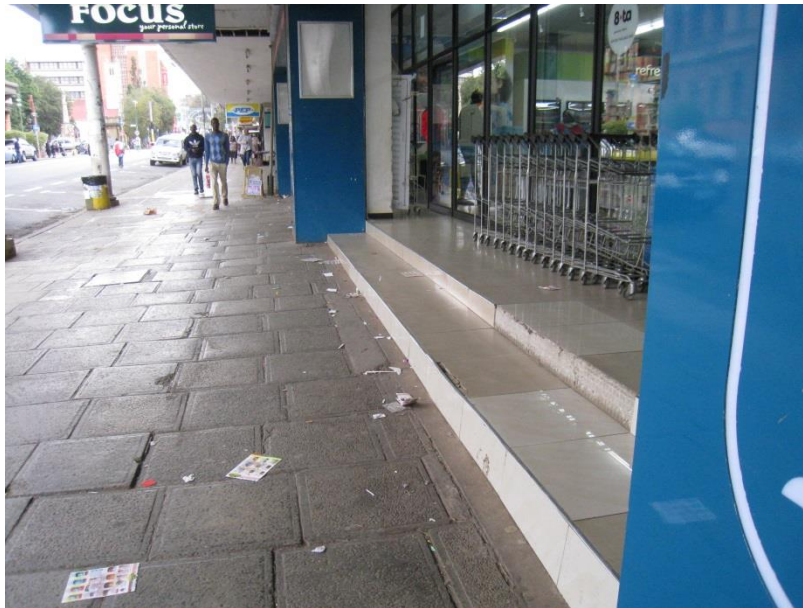
**Fig 103: Showing shopfront – threshold – pavement interface**

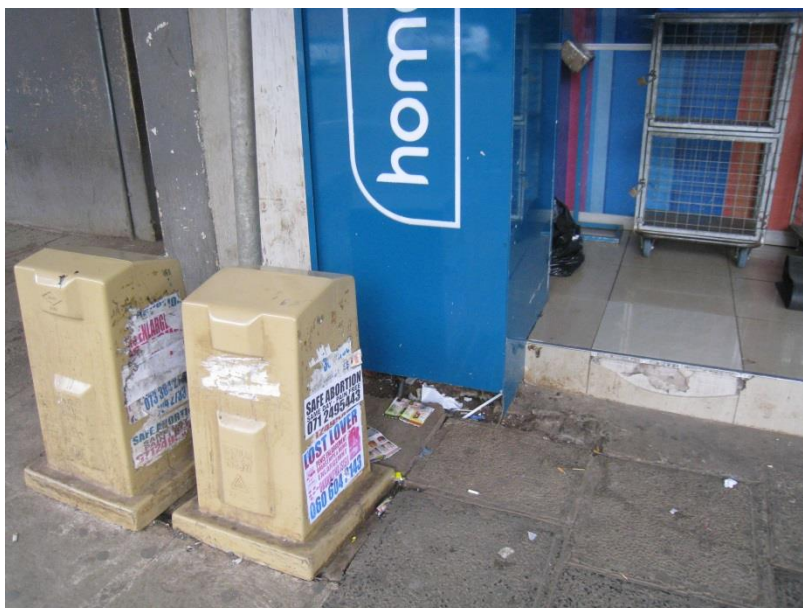
**Fig 104: Junction between 279 Church Street and its neighbor 277. Note proliferation of street paraphernalia**

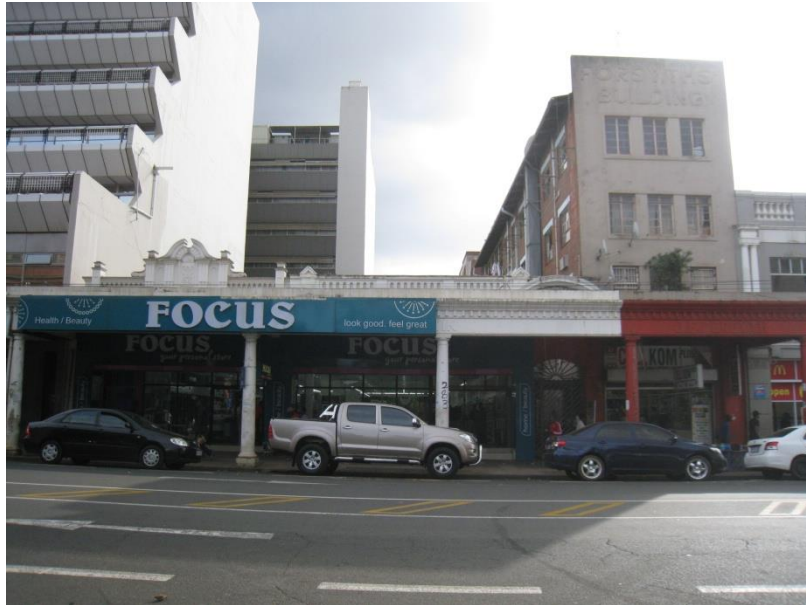
This structure has been extensively altered and has suffered from much abuse in recent years. There is little left by way of a shopfront, nor is there any evidence at street level as to what the original elevation offered. Further, the building may have been renovated in recent years, but it has not been maintained. These observations inform the recommendations.

**Fig 105: 281 Church Street in the centre adjacent to Forsyth's Buildings to the right**

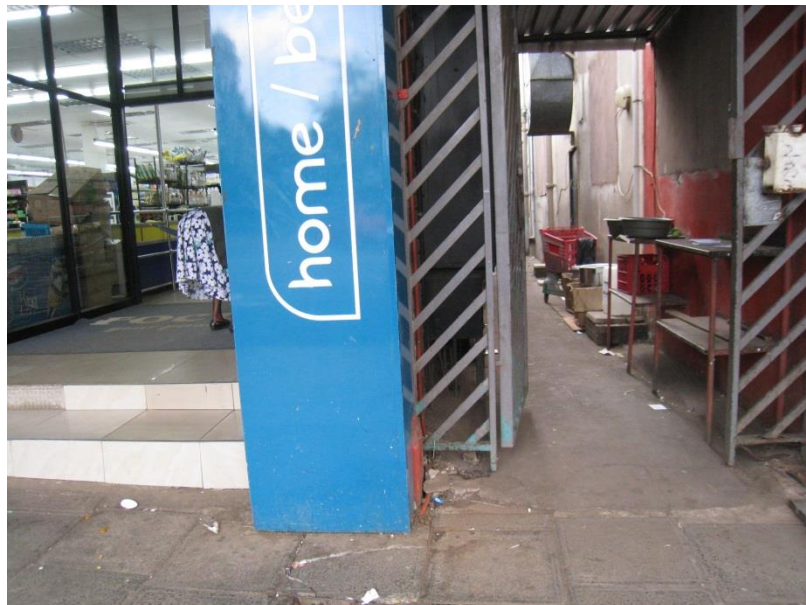
**Fig 106: Showing the alley to the back between 181 Church Street and Forsyth's Buildings**
